Infusion Port Dislodgment of Bilateral Breast Tissue Expanders After MRI

Zegzula HD, Lee WP. Infusion port dislodgment of bilateral breast tissue expanders after mri. *Ann Plast Surg* 2001;46:46-48

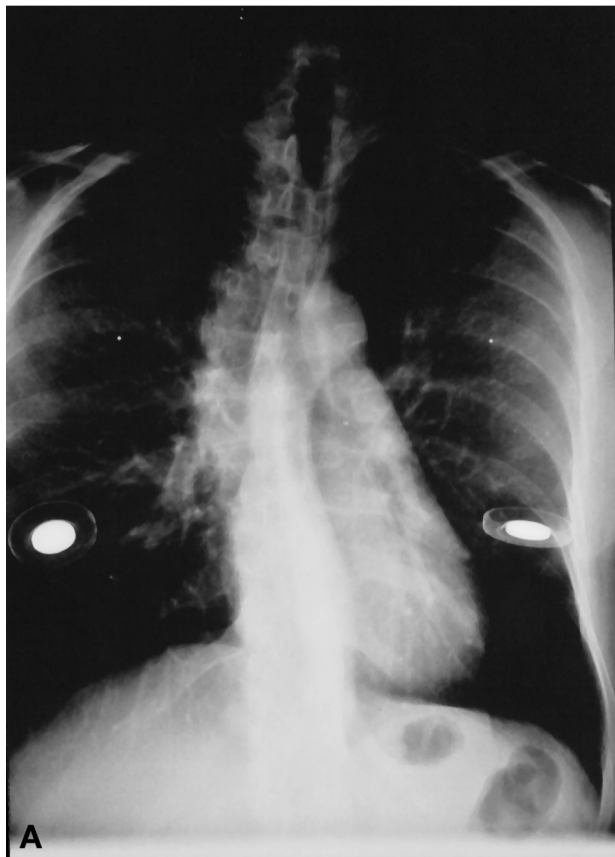
A 56-year-old woman with bilateral lobular breast carcinoma underwent bilateral modified radical mastectomy and immediate submuscular placement of tissue expanders. Two 600-ml McGhan (style 133 with Magna-Site integral port, Santa Barbara, CA) expanders were used. The procedure and postoperative recovery were uncomplicated. The patient elected to undergo chemotherapy, followed by radiation treatments, and this was started concurrently with serial expansion of her tissue expanders. Several weeks later, the patient developed new-onset back pain and was referred for MRI of her spine by her primary care physician. Subsequently the patient returned for additional expansion, but her infusion ports could not be located with the magnetic finder device. Implant migration was suspected, and radiographs were obtained that showed the infusion ports to be located at the most inferior aspect of the expander (FigA). The patient was brought to the operating room for implant revision. Examination of the implants revealed that the infusion ports were free floating within the intact silicone elastomer shells (FigB). It appeared that the ports had been pulled off or melted away from the internal lining of the implant. The patient's implants were replaced and she ultimately completed her reconstruction.

(A) Upright chest radiograph showing displacement of the expander infusion ports. (B) The infusion ports were found to be free floating within the intact elastomer shell. The arrow indicates the metallic port.
